GRINDSTONE-LOST-MUDDY CREEK DAM C-3

DEKALB COUNTY, MISSOURI

MO. 10384

**PHASE 1 INSPECTION REPORT
NATIONAL DAM SAFETY PROGRAM**

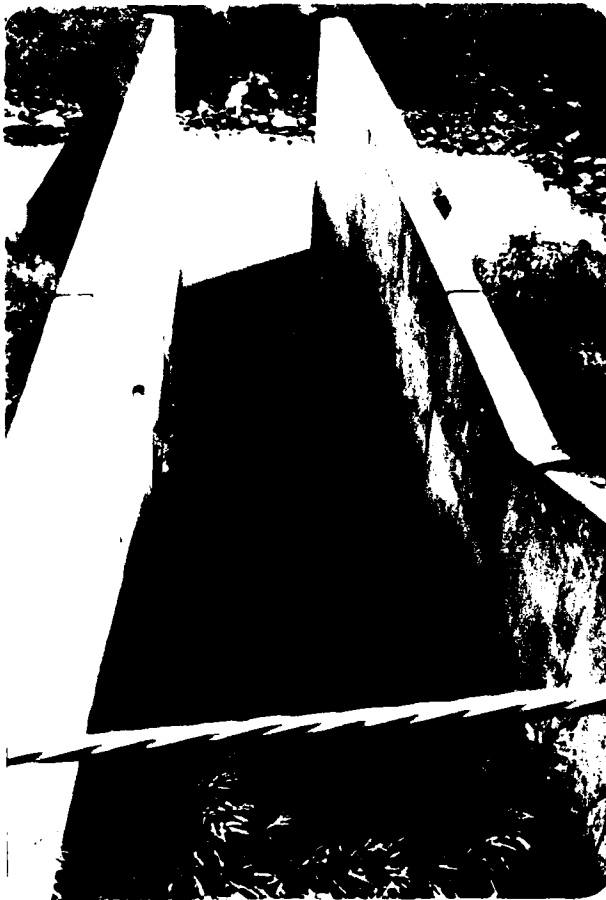
- (4) Downstream Slope. The downstream slope is well vegetated with adapted grasses. No cracks, slumps, or abnormal deformations were observed. No indications of seepage were observed on the slope or along the toe of the dam. The downstream slope is shown in Photos 4, 5, 6. The toe drain was not discharging at the time of inspection, but rust stains shown in Photo No. 17 indicate that the right drain has discharged in the past.

PHOTO NO. 17 - PRINCIPAL SPILLWAY OUTLET STRUCTURE. NOTE ENDS OF TOE DRAINS
